# Access Compliance Report Public Rights-of-Way (Curb Ramps)

Main Street: ANTONIO\_PKWY Cross Street: N/A Location: W

ADA ID: RPAT220208135205 Ramp Type: Type 1 - Perpendicular Diagonal Initial Pass/Fail: Pass Overall Compliance: No Severity Score: 16

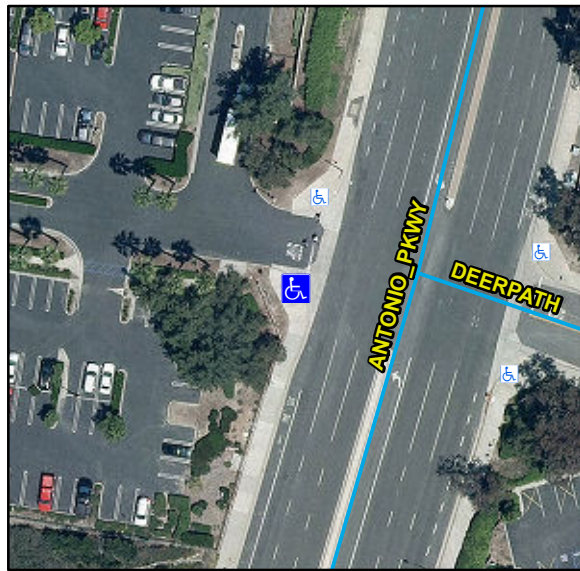
| Compliance | Description | Data | Compliance | Description | Data |
|---|---|---|---|---|---|
| No | Landing Cross Slope (%) | 2.1 | No | DWS Provided | No |
| Yes | Gutter Ponding | No | No | Curb Slope | 6.1 |
| No | Gutter Lip Height (in) | 0.25 | | Road Run Slope (%) | 1.9 |
| No | Gutter Run Slope (%) | 7.2 | | Road Cross Slope (%) | 7.1 |

Remove & Replace Curb Ramp With Two New Directional Ramps or Equivalent. Remove & Replace Gutter.
