# Access Compliance Report Public Rights-of-Way (Curb Ramps)

Main Street: MORNING\_TRAIL Cross Street: N/A Location: N

ADA ID: RPAT220208140103 Ramp Type: Type 4 - Parallel Initial Pass/Fail: Fail Overall Compliance: No Severity Score: 2

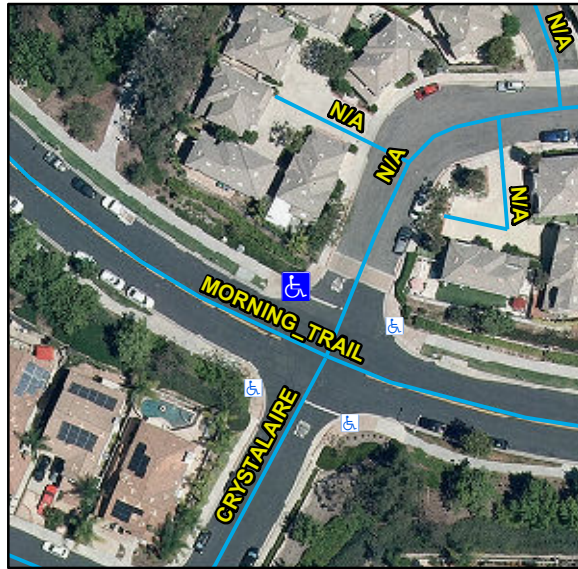
| Compliance | Description | Data | Compliance | Description | Data |
|---|---|---|---|---|---|
| Yes | Ramp Run Slope LT (%) | 4.2 | Yes | Ramp Run Slope RT (%) | 6.1 |
| No | Ramp Cross Slope LT (%) | 4.6 | No | Ramp Cross Slope RT (%) | 4.3 |

Remove & Replace Curb Ramp With Two New Directional Ramps or Equivalent.

R204.3, R304.5.3, STD 1115
