# Access Compliance Report Public Rights-of-Way (Curb Ramps)

Main Street: N/A Cross Street: MORNING\_TRAIL Location: E

ADA ID: RPAT220208140317 Ramp Type: Type 4 - Parallel Initial Pass/Fail: Fail Overall Compliance: No Severity Score: 60

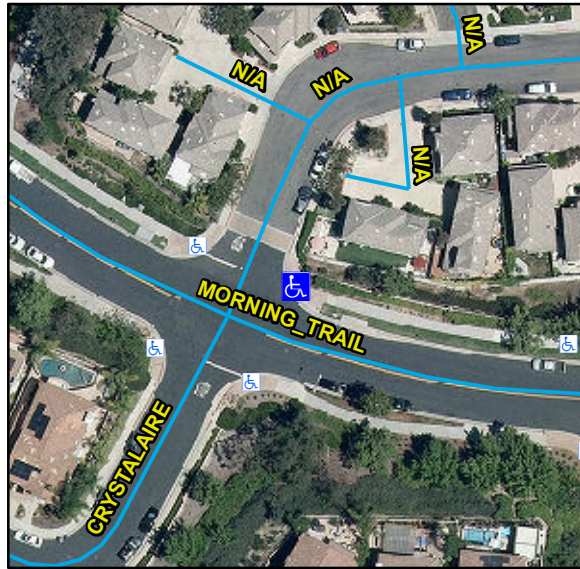
| Compliance | Description | Data | Compliance | Description | Data |
|---|---|---|---|---|---|
| Yes | Ramp Run Slope LT (%) | 0.9 | No | Ramp Run Slope RT (%) | 14 |
| No | Ramp Cross Slope LT (%) | 8.1 | No | Ramp Cross Slope RT (%) | 3.4 |

**Remove & Replace Curb Ramp With Two New Directional Ramps or Equivalent.**

**R304.5.3, R304.3.2, STD 1115**
