# Access Compliance Report Public Rights-of-Way (Curb Ramps)

Main Street: N/A Cross Street: MEANDERING TRAIL Location: N

ADA ID: RPAT220208140741 Ramp Type: Type 1 - Perpendicular Diagonal Initial Pass/Fail: Fail Overall Compliance: No Severity Score: 15

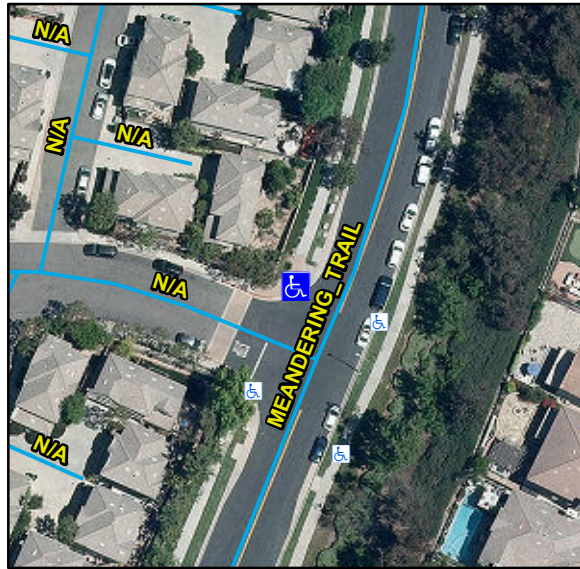
| Compliance | Description | Data | Compliance | Description | Data |
|---|---|---|---|---|---|
| No | Ramp Run Slope (%) | 11 | N/A | Flare Slope LT (%) | N/A |

Remove & Replace Curb Ramp With Two New Directional Ramps or Equivalent.

R304.2.2, R204.3, STD 1115
