# Access Compliance Report Public Rights-of-Way (Curb Ramps)

Main Street: MEANDERING\_TRAIL Cross Street: N/A Location: W

ADA ID: RPAT220208140936 Ramp Type: Type 1 - Perpendicular Diagonal Initial Pass/Fail: Fail Overall Compliance: No Severity Score: 15

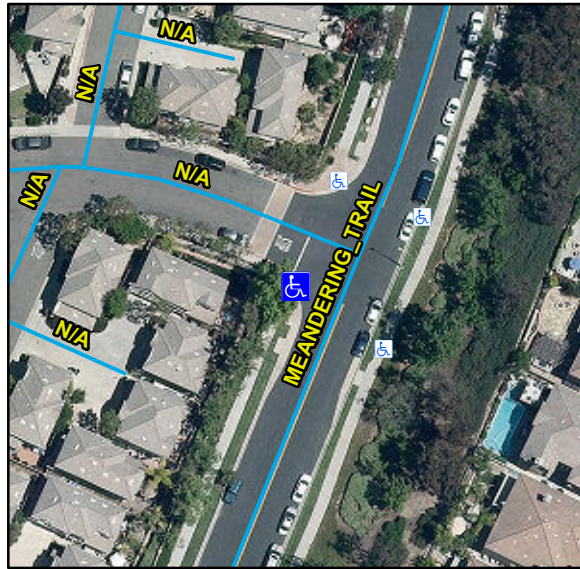
| Compliance | Description | Data | Compliance | Description | Data |
|---|---|---|---|---|---|
| No | Ramp Run Slope (%) | 10.5 | N/A | Flare Slope LT (%) | N/A |

Remove & Replace Curb Ramp With Two New Directional Ramps or Equivalent.

R304.2.2, R204.3, STD 1115
