# Access Compliance Report Public Rights-of-Way (Curb Ramps)

Main Street: PINEHURST\_ST Cross Street: MEANDERING\_TRAIL Location: SE

ADA ID: RPAT220208141301 Ramp Type: Type 1 - Perpendicular Diagonal Initial Pass/Fail: Fail Overall Compliance: No Severity Score: 16

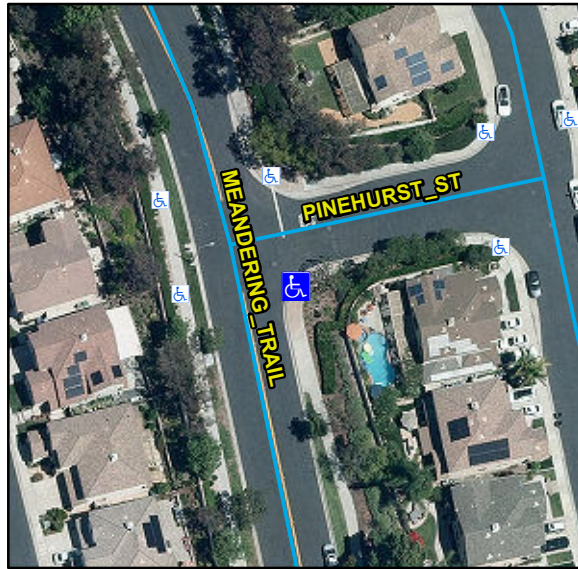
| Compliance | Description | Data | Compliance | Description | Data |
|---|---|---|---|---|---|
| No | Ramp Run Slope (%) | 8.5 | N/A | Flare Slope LT (%) | N/A |
| No | Ramp Cross Slope (%) | 4.6 | N/A | Flare Traversable LT | N/A |

Remove & Replace Curb Ramp With Two New Directional Ramps or Equivalent.

R304.2.2, R204.3, R304.5.3, STD 1115
