# Access Compliance Report Public Rights-of-Way (Curb Ramps)

Main Street: MEANDERING\_TRAIL Cross Street: PINEHURST\_ST Location: NE

ADA ID: RPAT220208141444 Ramp Type: Type 1 - Perpendicular Diagonal Initial Pass/Fail: Fail Overall Compliance: No Severity Score: 16

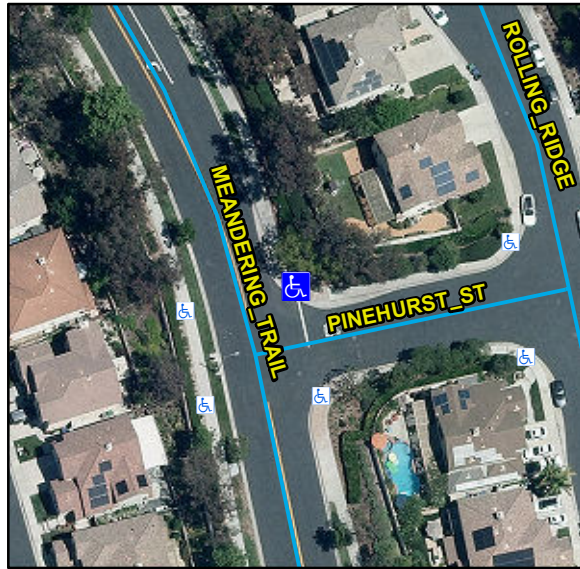
| Compliance | Description | Data | Compliance | Description | Data |
|---|---|---|---|---|---|
| No | Ramp Run Slope (%) | 9.7 | N/A | Flare Slope LT (%) | N/A |
| No | Ramp Cross Slope (%) | 2.2 | N/A | Flare Traversable LT | N/A |

Remove & Replace Curb Ramp With Two New Directional Ramps or Equivalent.

R204.3, R304.2.2, R304.5.3, STD 1115
