# Access Compliance Report Public Rights-of-Way (Curb Ramps)

| Main Street: FLINTRIDGE_AVE | | Cross Street: FLINTRIDGE_AVE | | Location: | NE |
| ADA ID: RPAT220208142648 | Ramp Type: Type 4 - Parallel | Initial Pass/Fail: Fail | Overall Compliance: No | Severity Score: | 15 |

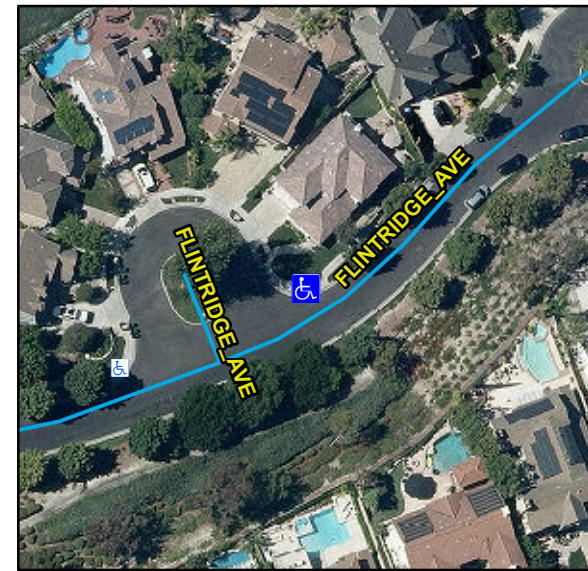
| Compliance | Description | Data | Compliance | Description | Data |
|---|---|---|---|---|---|
| Yes | Ramp Run Slope LT (%) | 4.9 | No | Ramp Run Slope RT (%) | 11.3 |

Possible Solutions:

**Remove & Replace Curb Ramp With Two New Directional Ramps or Equivalent.**

**R304.3.2, STD 1115**
