# Access Compliance Report Public Rights-of-Way (Curb Ramps)

Main Street: FLINTRIDGE\_AVE Cross Street: FLINTRIDGE\_AVE Location: N

ADA ID: RPAT220208143007 Ramp Type: Type 4 - Parallel Initial Pass/Fail: Fail Overall Compliance: No Severity Score: 2

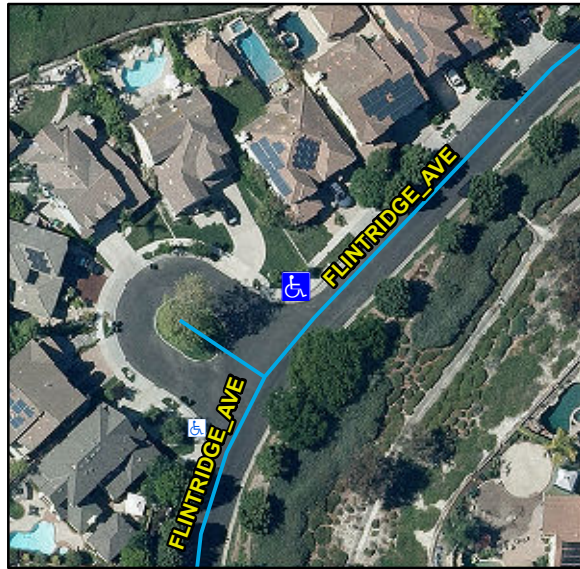
| Compliance | Description | Data | Compliance | Description | Data |
|---|---|---|---|---|---|
| No | Ramp Cross Slope LT (%) | 3.2 | Yes | Ramp Cross Slope RT (%) | 1.6 |

**Remove & Replace Curb Ramp With Two New Directional Ramps or Equivalent.**

**R204.3, R304.5.3, STD 1115**
