# Access Compliance Report Public Rights-of-Way (Curb Ramps)

Main Street: SANTE\_FE\_RD Cross Street: VALENCIA\_AVE Location: NW

ADA ID: RPAT220218165826 Ramp Type: Type 1 - Perpendicular Diagonal Initial Pass/Fail: Fail Overall Compliance: No Severity Score: 2

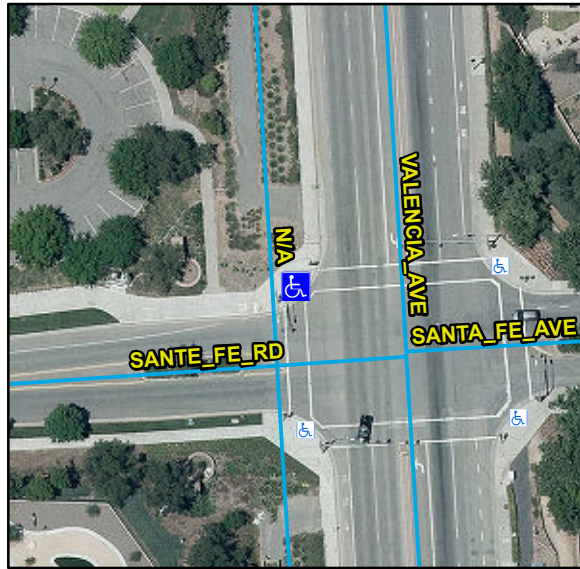
| Compliance | Description | Data | Compliance | Description | Data |
|---|---|---|---|---|---|
| No | Ramp Cross Slope (%) | 4.5 | N/A | Flare Traversable LT | No |
| N/A | Gutter Ponding | No | No | Curb Slope | 7.1 |

Remove & Replace Curb Ramp With Two New Directional Ramps or Equivalent.

R304.2.2, R304.5.3, STD 1115
