# Access Compliance Report Public Rights-of-Way (Curb Ramps)

Main Street: VALENCIA\_AVE Cross Street: SANTE\_FE\_AVE Location: NE

ADA ID: RPAT220218171919 Ramp Type: Type 1 - Perpendicular Diagonal Initial Pass/Fail: Fail Overall Compliance: No Severity Score: 5

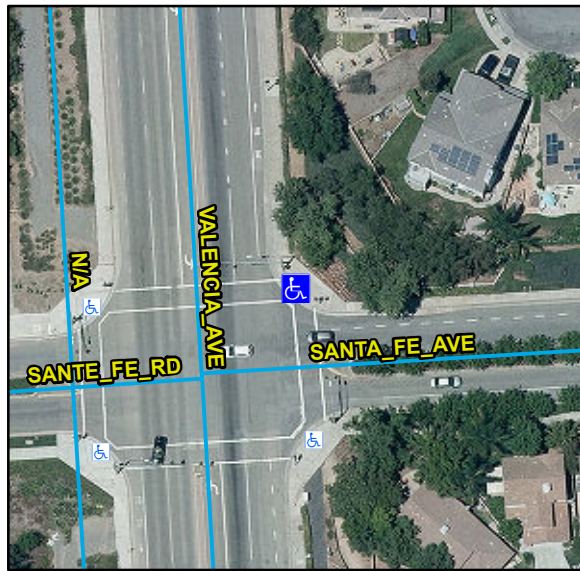
| Compliance | Description | Data | Compliance | Description | Data |
|---|---|---|---|---|---|
| No | Ramp Width (in) | 45 | | | N/A |
| No | Ramp Cross Slope (%) | 5 | N/A | Flare Traversable LT | N/A |

Remove & Replace Curb Ramp With Two New Directional Ramps or Equivalent.
