# Access Compliance Report Public Rights-of-Way (Curb Ramps)

Main Street: SANTA\_FE\_AVE Cross Street: VALENCIA\_AVE Location: SE

ADA ID: RPAT220218172944 Ramp Type: Type 1 - Perpendicular Diagonal Initial Pass/Fail: Fail Overall Compliance: No Severity Score: 2

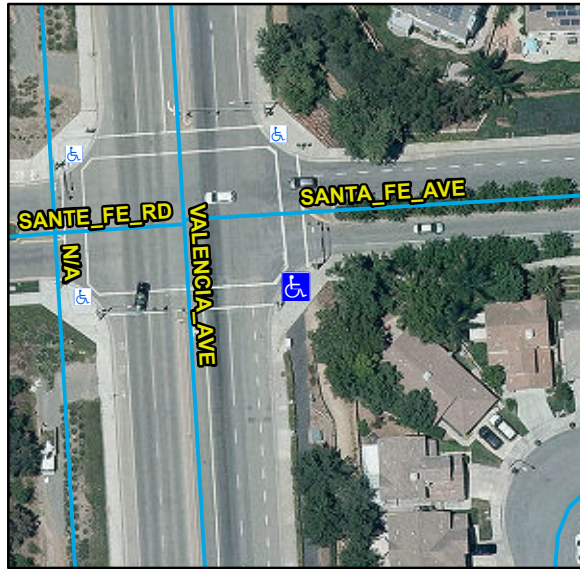
| Compliance | Description | Data | Compliance | Description | Data |
|---|---|---|---|---|---|
| No | Ramp Cross Slope (%) | 3.3 | N/A | Flare Traversable LT | N/A |
| N/A | Gutter Ponding | N/A | No | Curb Slope | 11 |

Remove & Replace Curb Ramp With Two New Directional Ramps or Equivalent.

R304.2.2, R304.5.3, STD 1115
