# Access Compliance Report Public Rights-of-Way (Curb Ramps)

Main Street: VALENCIA\_AVE Cross Street: SANTA\_FE\_AVE Location: SW

ADA ID: RPAT220218173821 Ramp Type: Type 1 - Perpendicular Diagonal Initial Pass/Fail: Pass Overall Compliance: No Severity Score: 25

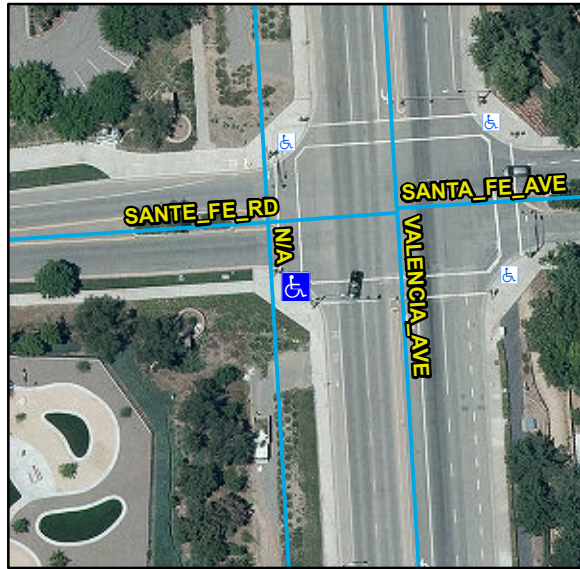
| Compliance | Description | Data | Compliance | Description | Data |
|---|---|---|---|---|---|
| No | Ramp Cross Slope (%) | 5.5 | N/A | Flare Traversable LT | No |
| No | Landing Cross Slope (%) | 6.4 | Yes | DWS Provided | Yes |
| Yes | Gutter Ponding | No | No | Curb Slope | 5.2 |
| No | Gutter Run Slope (%) | 6 | | Road Cross Slope (%) | 1.1 |
| No | Gutter Cross Slope (%) | 6.3 | | | |

Remove & Replace Curb Ramp With Two New Directional Ramps or Equivalent. Remove & Replace Gutter.

R304.2.2, R304.5.3, R304.5.4, STD 1115
