# Access Compliance Report Public Rights-of-Way (Curb Ramps)

Main Street: BOLSA\_AVE\_FRONTAGE\_ROAD Cross Street: N/A Location: S

ADA ID: RPAT220221152401 Ramp Type: Type 4 - Parallel Initial Pass/Fail: Fail Overall Compliance: No Severity Score: 2

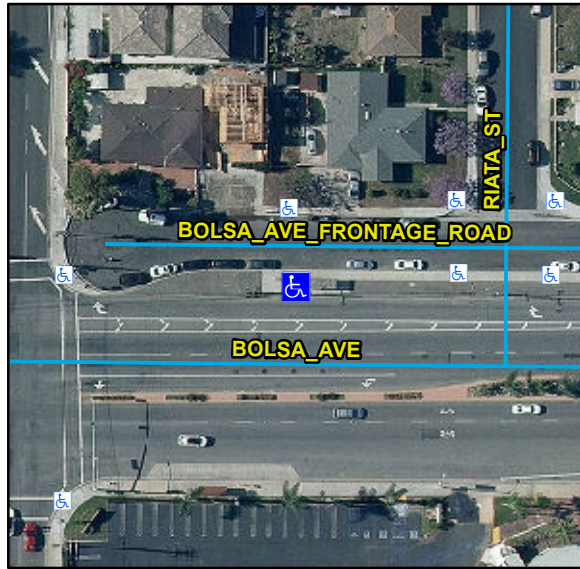
| Compliance | Description | Data | Compliance | Description | Data |
|---|---|---|---|---|---|
| Yes | Ramp Cross Slope LT (%) | 1.7 | No | Ramp Cross Slope RT (%) | 2.2 |

Remove & Replace Entire Ramp.

R304.5.3, STD 1115
