# Access Compliance Report Public Rights-of-Way (Curb Ramps)

Main Street: LINCOLN\_AVE Cross Street: BATAVIA\_ST Location: NE

ADA ID: RPAT220221160500 Ramp Type: Type 1 - Perpendicular Diagonal Initial Pass/Fail: Pass Overall Compliance: No Severity Score: 13

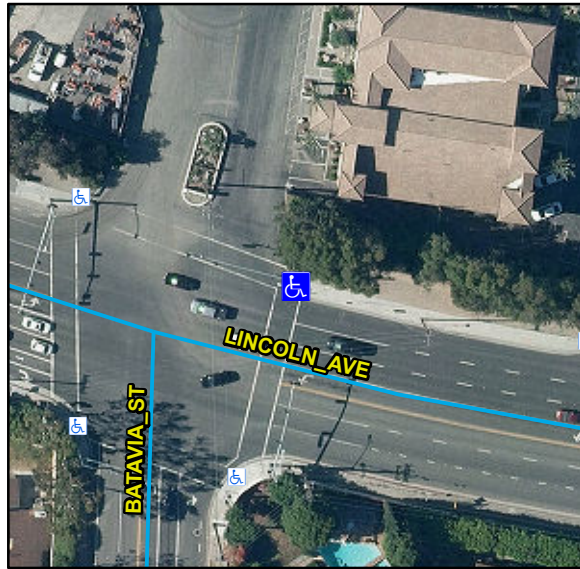
| Compliance | Description | Data | Compliance | Description | Data |
|---|---|---|---|---|---|
| N/A | Ramp Length (in) | 118 | Yes | Flare Type LT | Curbed2 |
| Yes | Ramp Width (in) | 63 | | | |
| Yes | Ramp Run Slope (%) | 7.6 | N/A | Flare Slope LT (%) | N/A |
| Yes | Ramp Cross Slope (%) | 1.6 | N/A | Flare Traversable LT | N/A |
| No | Landing Cross Slope (%) | 2.8 | Yes | DWS Provided | Yes |
| Yes | Gutter Ponding | No | No | Curb Slope | 5.8 |
| No | Gutter Run Slope (%) | 5.4 | | Road Cross Slope (%) | 3 |
| No | Gutter Cross Slope (%) | 2.4 | | | |

Remove & Replace Curb Ramp With Two New Directional Ramps or Equivalent. Remove & Replace Gutter.
