# Access Compliance Report Public Rights-of-Way (Curb Ramps)

Main Street: N/A Cross Street: NEWPORT\_AVE Location: NE

ADA ID: RPAT220222134314 Ramp Type: Type 4 - Parallel Initial Pass/Fail: Fail Overall Compliance: No Severity Score: 16

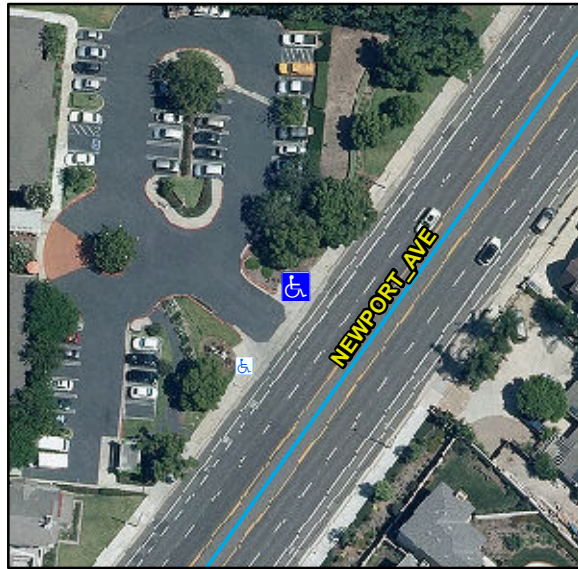
| Compliance | Description | Data | Compliance | Description | Data |
|---|---|---|---|---|---|
| No | Ramp Run Slope LT (%) | 9.2 | Yes | Ramp Run Slope RT (%) | 2.3 |
| No | Ramp Cross Slope LT (%) | 2.9 | No | Ramp Cross Slope RT (%) | 2.2 |
| No | Gutter Lip Height (in) | 0.5 | | Road Run Slope (%) | N/A |

Remove & Replace Entire Ramp. Grind Gutter Lip.

R304.3.2, R304.5.3, R302.7.2, STD 1115
