# Access Compliance Report Public Rights-of-Way (Curb Ramps)

| Main Street: N/A | | Cross Street: NEWPORT_AVE | | Location: | SW |
| ADA ID: RPAT220222135234 | Ramp Type: Type 3 - Combination 1 | Initial Pass/Fail: Pass | Overall Compliance: No | Severity Score: | 19 |

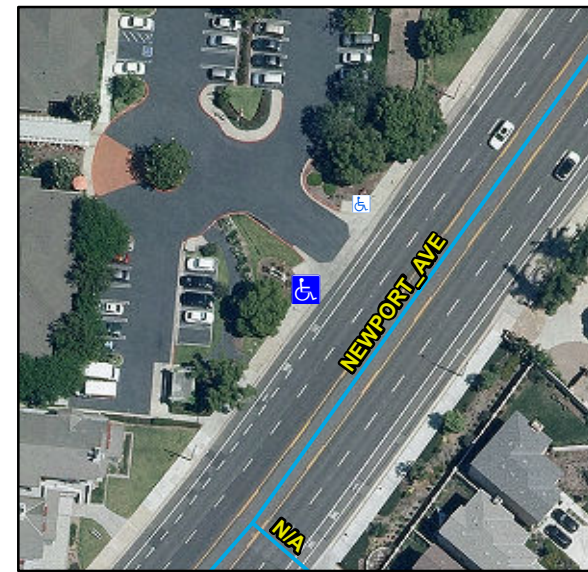
**R304.2.2, R304.5.3, R304.2.1, R305, R304.5.4, STD 1115**

| Compliance | Description | Data | Compliance | Description | Data |
|---|---|---|---|---|---|
| Yes | Ramp Cross Slope LT (%) | 1.7 | No | Ramp Cross Slope RT (%) | 2.9 |
| No | Landing Length (in) | 42 | | | N/A |
| No | Landing Width (in) | 46 | N/A | Flare Slope RT (%) | N/A |
| Yes | Landing Cross Slope (%) | 0.5 | No | DWS Provided | No |
| Yes | Gutter Ponding | No | No | Curb Slope | 9.4 |
| No | Gutter Run Slope (%) | 6.5 | | Road Cross Slope (%) | N/A |

**Remove & Replace Entire Ramp. Remove & Replace Gutter.**

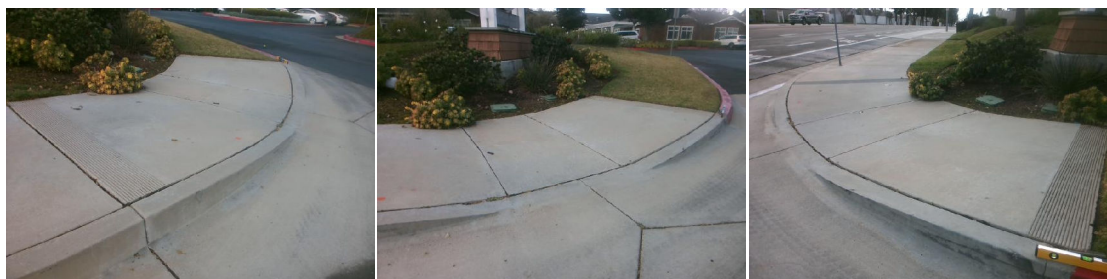
| Compliance | Description | Data | Compliance | Description | Data |
| N/A | Ramp Length LT (in) | 78 | N/A | Ramp Length RT (in) | 81 |
| Yes | Ramp Width LT (in) | 90 | Yes | Ramp Width RT (in) | 90 |
| Yes | Ramp Run Slope LT (%) | 3.1 | Yes | Ramp Run Slope RT (%) | 8.2 |

Possible Solutions:
