# Access Compliance Report Public Rights-of-Way (Curb Ramps)

Main Street: N/A Cross Street: 17TH\_ST Location: SW

ADA ID: RPAT220222143150 Ramp Type: Type 1 - Perpendicular Diagonal Initial Pass/Fail: Fail Overall Compliance: No Severity Score: 2

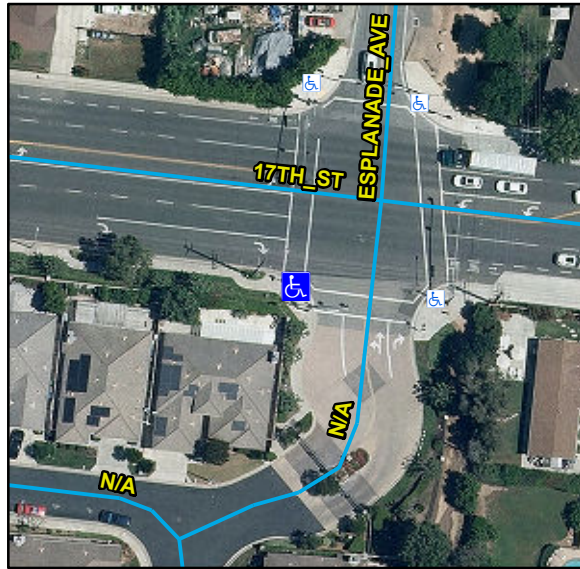
| Compliance | Description | Data | Compliance | Description | Data |
|---|---|---|---|---|---|
| No | Ramp Cross Slope (%) | 3.1 | N/A | Flare Traversable LT | No |

Remove & Replace Curb Ramp With Two New Directional Ramps or Equivalent.

R304.2.2, R304.5.3, STD 1115
