# Access Compliance Report Public Rights-of-Way (Curb Ramps)

Main Street: N/A Cross Street: DODGE\_AVE Location: NE

ADA ID: RPAT220222152126 Ramp Type: Type 3 - Combination 1 Initial Pass/Fail: Fail Overall Compliance: No Severity Score: 4

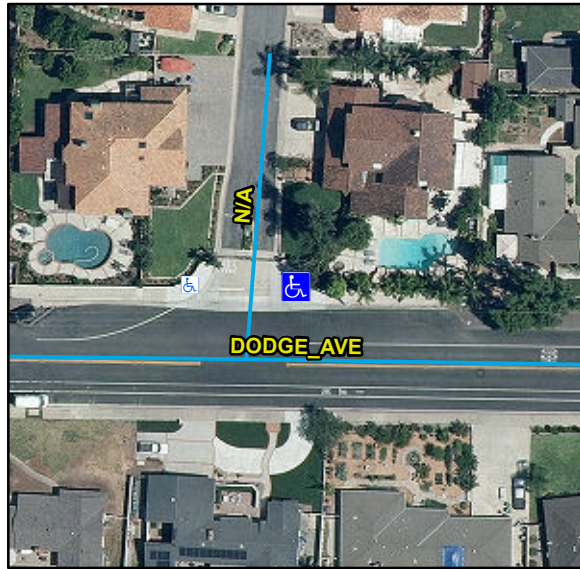
| Compliance | Description | Data | Compliance | Description | Data |
|---|---|---|---|---|---|
| No | Ramp Width LT (in) | 44 | Yes | Ramp Width RT (in) | 51 |

Remove & Replace Entire Ramp.

R304.5.1, STD 1115
