# Access Compliance Report Public Rights-of-Way (Curb Ramps)

Main Street: DODGE\_AVE Cross Street: N/A Location: NW

ADA ID: RPAT220222153046 Ramp Type: Type 3 - Combination 1 Initial Pass/Fail: Pass Overall Compliance: No Severity Score: 0

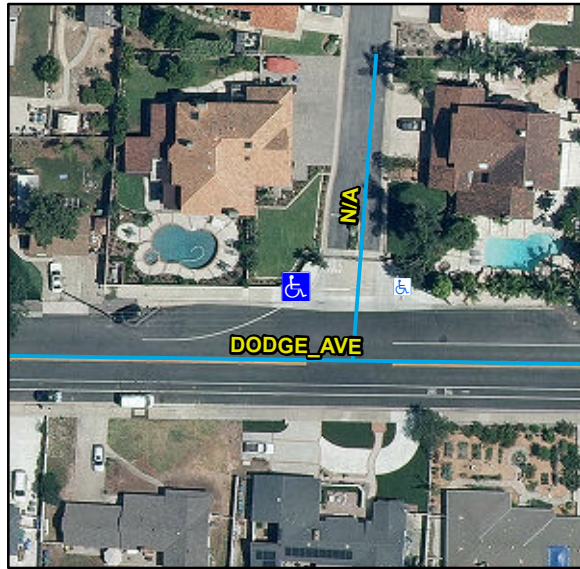
| Compliance | Description | Data | Compliance | Description | Data |
|---|---|---|---|---|---|
| No | Landing Length (in) | 58 | | | N/A |
| No | Landing Width (in) | N/A | N/A | Flare Slope RT (%) | N/A |
| No | Landing Run Slope (%) | 2.2 | N/A | Flare Traversable RT | N/A |

Remove & Replace Landing.

R304.2.1, R304.2.2-Perp, R304.3.2-Para, STD 1115

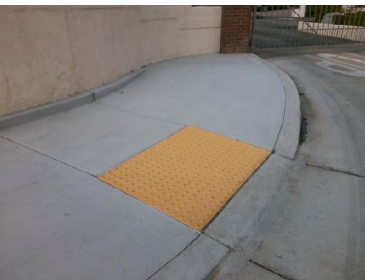
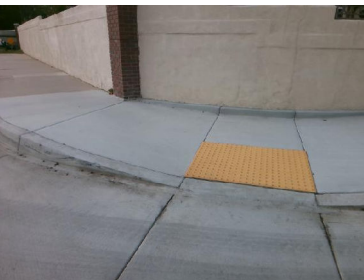
| Compliance | Description | Data | Compliance | Description | Data |
|---|---|---|---|---|---|
| Yes | Overall Surface Condition: Acceptable | | | | |
