# Access Compliance Report Public Rights-of-Way (Curb Ramps)

Main Street: N/A Cross Street: DODGE\_AVE Location: SW

ADA ID: RPAT220222154103 Ramp Type: Type 4 - Parallel Initial Pass/Fail: Fail Overall Compliance: No Severity Score: 2

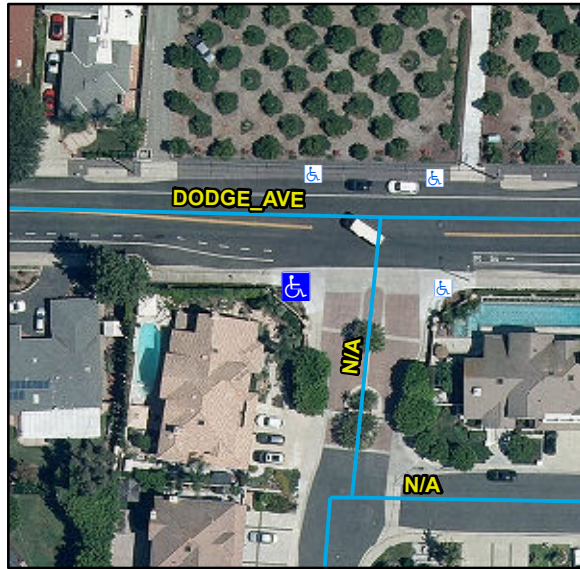
| Compliance | Description | Data | Compliance | Description | Data |
|---|---|---|---|---|---|
| No | Ramp Cross Slope LT (%) | 2.1 | Yes | Ramp Cross Slope RT (%) | 1.3 |

Remove & Replace Entire Ramp.
