# Access Compliance Report Public Rights-of-Way (Curb Ramps)

Main Street: N/A Cross Street: DODGE\_AVE Location: SE

ADA ID: RPAT220222154705 Ramp Type: Type 4 - Parallel Initial Pass/Fail: Pass Overall Compliance: No Severity Score: 0

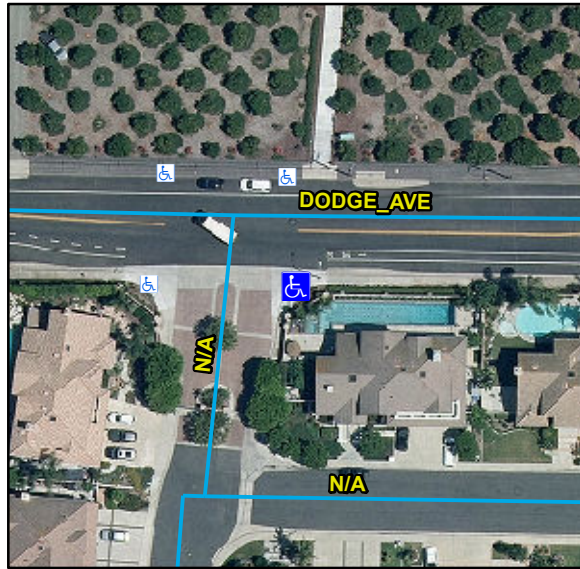
## Field Measurements/Component Compliance

Possible Solutions:

Remove & Replace Landing.

OC Std/PROW:

R304.2.1, STD 1115
