# Access Compliance Report Public Rights-of-Way (Curb Ramps)

Main Street: N/A Cross Street: DODGE\_AVE Location: NE

ADA ID: RPAT220222160231 Ramp Type: Type 3 - Combination 1 Initial Pass/Fail: Fail Overall Compliance: No Severity Score: 5

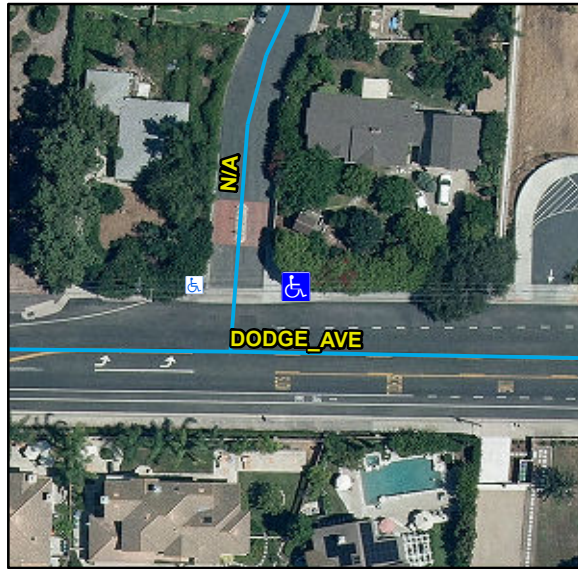
| Compliance | Description | Data | Compliance | Description | Data |
|---|---|---|---|---|---|
| No | Ramp Width LT (in) | 46 | No | Ramp Width RT (in) | 46 |

Remove & Replace Entire Ramp.

R304.5.1, STD 1115
