# Access Compliance Report Public Rights-of-Way (Curb Ramps)

Main Street: N/A Cross Street: DODGE\_AVE Location: NW

ADA ID: RPAT220222160917 Ramp Type: Type 4 - Parallel Initial Pass/Fail: Fail Overall Compliance: No Severity Score: 16

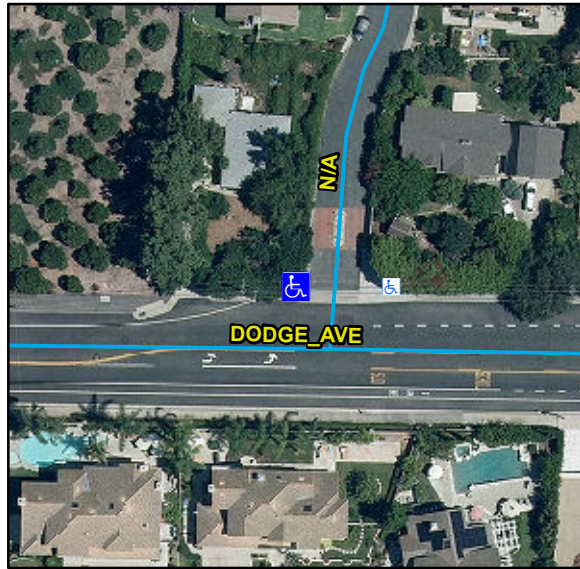
Vegetation

| Compliance | Description | Data | Compliance | Description | Data |
|---|---|---|---|---|---|
| No | Ramp Run Slope LT (%) | 12 | N/A | Ramp Run Slope RT (%) | -9999 |
| No | Ramp Cross Slope LT (%) | 2.5 | N/A | Ramp Cross Slope RT (%) | -9999 |

Remove & Replace Entire Ramp.

R204.3, R304.3.2, R304.5.3, STD 1115

Total Cost: \$ 2000
