# Access Compliance Report Public Rights-of-Way (Curb Ramps)

Main Street: SANDHURST\_ST Cross Street: DODGE\_AVE Location: SW

ADA ID: RPAT220222162047 Ramp Type: Type 4 - Parallel Initial Pass/Fail: Pass Overall Compliance: No Severity Score: 5

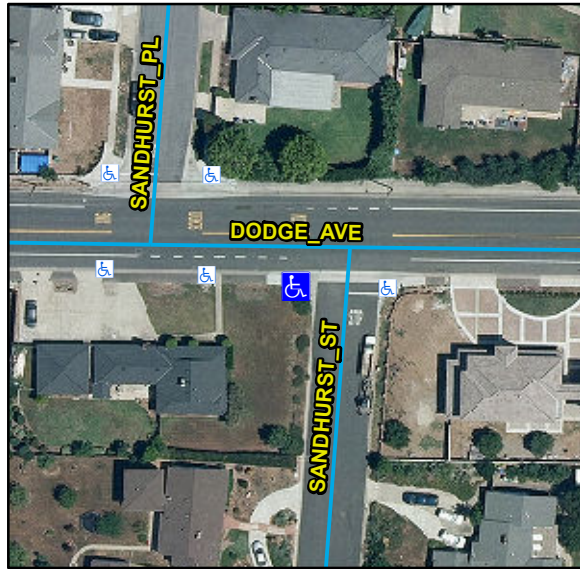
| Compliance | Description | Data | Compliance | Description | Data |
|---|---|---|---|---|---|
| No | Gutter Ponding | Yes | No | Curb Slope | 12 |
| No | Gutter Run Slope (%) | 7.6 | | Road Cross Slope (%) | N/A |

### Possible Solutions:

Remove & Replace Entire Ramp. Remove & Replace Gutter.

R304.2.2, R304.2.1, R302.7, R304.5.4, STD 1115
