# Access Compliance Report Public Rights-of-Way (Curb Ramps)

Main Street: SANDHURST\_ST Cross Street: DODGE\_AVE Location: SE

ADA ID: RPAT220222162630 Ramp Type: Type 4 - Parallel Initial Pass/Fail: Pass Overall Compliance: No Severity Score: 0

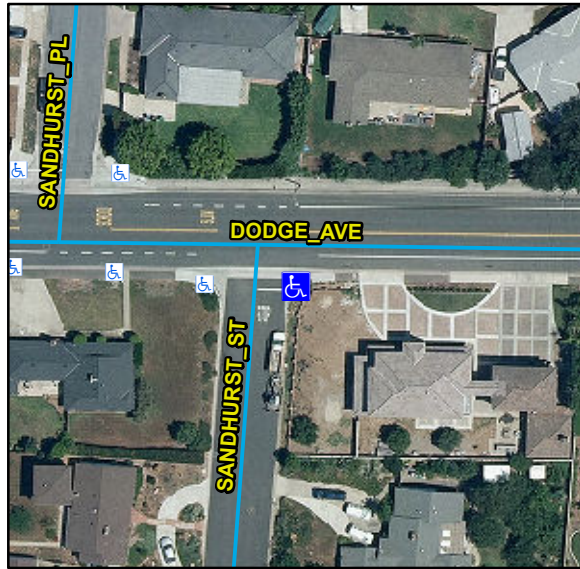
| Compliance | Description | Data | Compliance | Description | Data |
|---|---|---|---|---|---|
| Yes | Gutter Ponding | No | No | Curb Slope | 11.5 |
| No | Gutter Cross Slope (%) | 3.2 | Yes | Perpendicular Joint Present | Yes |

Remove & Replace Entire Ramp. Remove & Replace Gutter.

R304.2.2, R304.2.1, R304.5.3, STD 1115
