# Access Compliance Report Public Rights-of-Way (Curb Ramps)

Main Street: ESPLANADE\_AVE Cross Street: ESPLANADE\_AVE Location: W

ADA ID: RPAT220222163311 Ramp Type: Type 1 - Perpendicular Initial Pass/Fail: Pass Overall Compliance: No Severity Score: 14

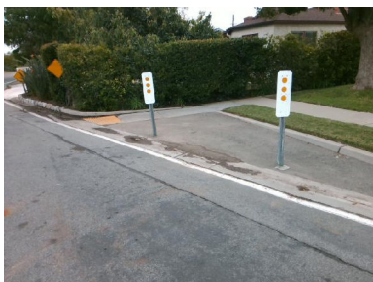
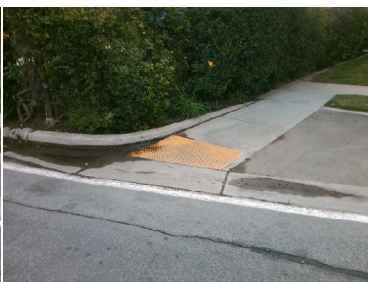
| Compliance | Description | Data | Compliance | Description | Data |
|---|---|---|---|---|---|
| No | Landing Run Slope (%) | 2.8 | N/A | Flare Traversable RT | No |
| No | Landing Cross Slope (%) | 2.8 | Yes | DWS Provided | Yes |
| N/A | Landing Shared | No | No | DWS Full Width | No |
| N/A | Clear Space | N/A | No | DWS Offset Left (in) | 4 |
| No | Gutter Ponding | Yes | No | Curb Slope | 6.1 |
| No | Gutter Run Slope (%) | 5.1 | | Road Cross Slope (%) | N/A |

Remove & Replace Entire Ramp. Remove & Replace Gutter.
