# Access Compliance Report Public Rights-of-Way (Curb Ramps)

Main Street: DOE\_RUN Cross Street: NEWPORT\_AVE Location: W

ADA ID: RPAT220222171216 Ramp Type: Type 1 - Perpendicular Initial Pass/Fail: Pass Overall Compliance: No Severity Score: 10

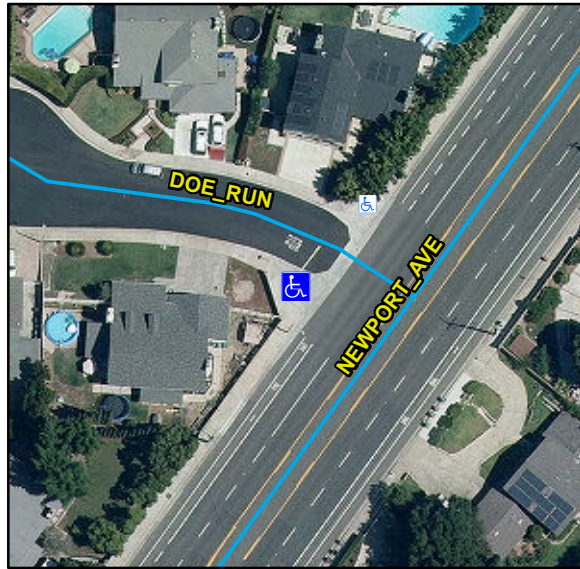
| Compliance | Description | Data | Compliance | Description | Data |
|---|---|---|---|---|---|
| No | Landing Width (in) | 46 | Yes | Flare Slope RT (%) | 9.1 |
| No | Landing Cross Slope (%) | 4 | Yes | DWS Provided | Yes |
| Yes | Gutter Ponding | No | No | Curb Slope | 6.8 |
| No | Gutter Run Slope (%) | 11.7 | | Road Cross Slope (%) | N/A |
| No | Gutter Cross Slope (%) | 3 | | | |

Remove & Replace Entire Ramp. Remove & Replace Gutter.
