# Access Compliance Report Public Rights-of-Way (Curb Ramps)

Main Street: DOE\_RUN Cross Street: NEWPORT\_AVE Location: N

ADA ID: RPAT220222171645 Ramp Type: Type 1 - Perpendicular Initial Pass/Fail: Pass Overall Compliance: No Severity Score: 0

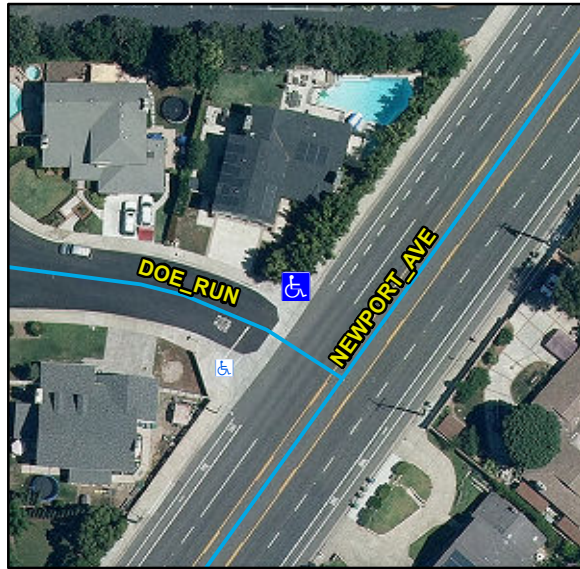
| Compliance | Description | Data | Compliance | Description | Data |
|---|---|---|---|---|---|
| Yes | Gutter Ponding | No | No | Curb Slope | 11 |

Remove & Replace Entire Ramp.

R304.2.2, R304.2.1, STD 1115

Total Cost: \$ 3080
