# Access Compliance Report Public Rights-of-Way (Curb Ramps)

Main Street: HIDEAWAY\_DR Cross Street: NEWPORT\_BLVD Location: SW

ADA ID: RPAT220222173800 Ramp Type: Type 4 - Parallel Initial Pass/Fail: Fail Overall Compliance: No Severity Score: 60

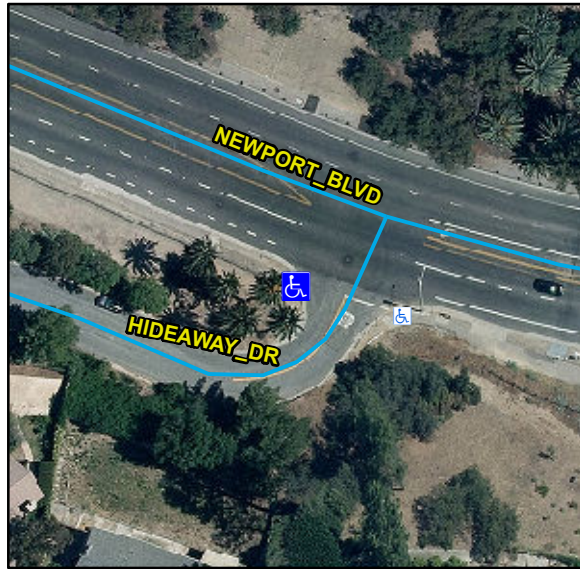
| Compliance | Description | Data | Compliance | Description | Data |
|---|---|---|---|---|---|
| No | Ramp Run Slope LT (%) | 16.7 | Yes | Ramp Run Slope RT (%) | 0.7 |
| No | Ramp Cross Slope LT (%) | 7.1 | No | Ramp Cross Slope RT (%) | 9.3 |
| No | Gutter Lip Height (in) | 1 | | Road Run Slope (%) | N/A |

Remove & Replace Entire Ramp. Grind Gutter Lip.

R304.3.2, R304.5.3, R302.7.2, STD 1115
