# Access Compliance Report Public Rights-of-Way (Curb Ramps)

Main Street: HIDEAWAY\_DR Cross Street: NEWPORT\_BLVD Location: SE

ADA ID: RPAT220222174258 Ramp Type: Type 4 - Parallel Initial Pass/Fail: Fail Overall Compliance: No Severity Score: 60

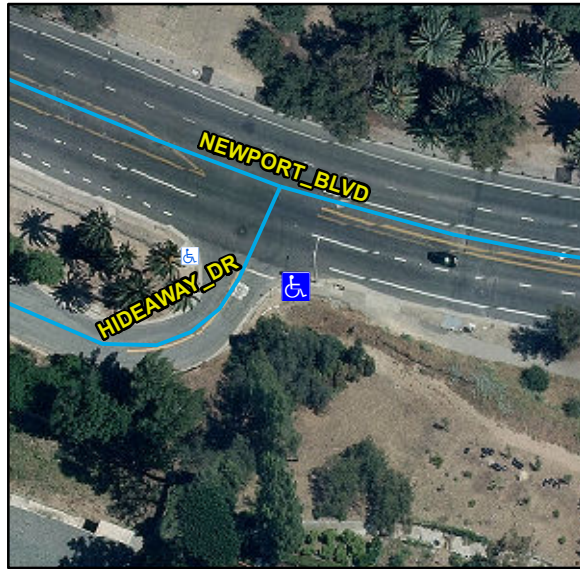
R304.5.3, R304.3.2, STD 1115

| Compliance | Description | Data | Compliance | Description | Data |
|---|---|---|---|---|---|
| Yes | Ramp Run Slope LT (%) | 6.1 | No | Ramp Run Slope RT (%) | 16.2 |
| No | Ramp Cross Slope LT (%) | 5 | No | Ramp Cross Slope RT (%) | 8.4 |

Remove & Replace Entire Ramp.
