# Access Compliance Report Public Rights-of-Way (Curb Ramps)

Main Street: DOE\_RUN Cross Street: NEWPORT\_BLVD Location: SE

ADA ID: RPAT220222175929 Ramp Type: Type 6 - Directional 1 Initial Pass/Fail: Fail Overall Compliance: No Severity Score: 19

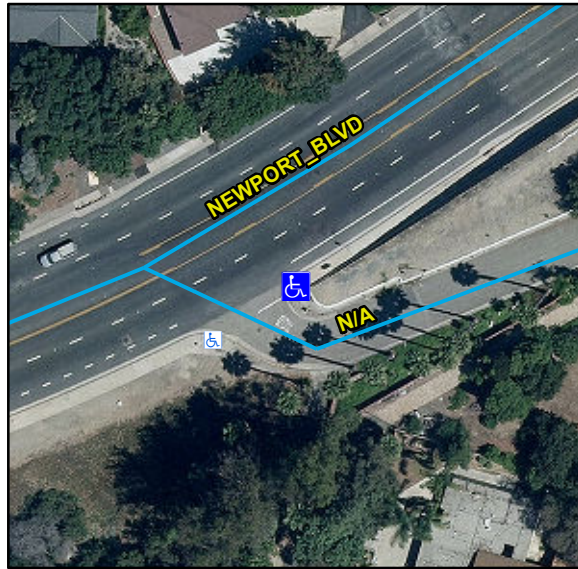
| Compliance | Description | Data | Compliance | Description | Data |
|---|---|---|---|---|---|
| No | Ramp Width (in) | 42 | | | N/A |
| No | Ramp Cross Slope (%) | 6 | N/A | Flare Traversable LT | N/A |

Remove & Replace Entire Ramp.
