# Access Compliance Report

## Public Rights-of-Way

### (Curb Ramps)

Main Street: KELLOGG\_DR Cross Street: YORBA\_LINDA\_BLVD Location: SE

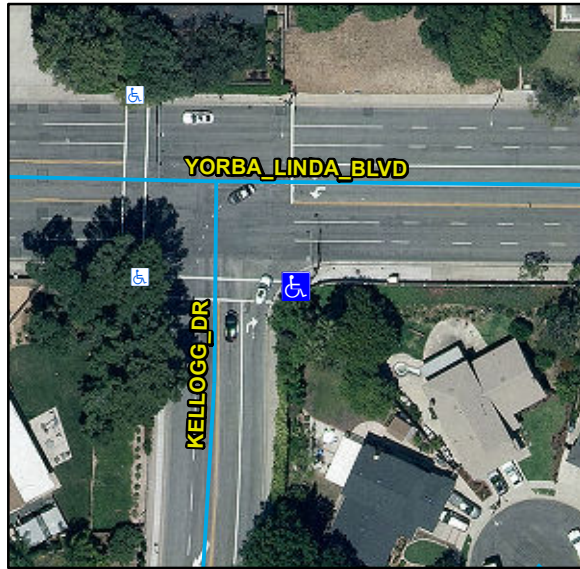
ADA ID: RPAT220223091312 Ramp Type: Type 3 - Combination 1 Initial Pass/Fail: Fail Overall Compliance: No Severity Score: 2

| Compliance | Description | Data | Compliance | Description | Data |
|---|---|---|---|---|---|
| No | Ramp Cross Slope (%) | 3.7 | N/A | Flare Traversable LT | Yes |
| N/A | Gutter Ponding | N/A | No | Curb Slope | 5.4 |

Remove & Replace Entire Ramp.

R304.2.2, R304.5.3, STD 1115

Total Cost: \$ 3080
