# Access Compliance Report Public Rights-of-Way (Curb Ramps)

Main Street: **HAMER\_DR** Cross Street: **CARTLEN\_DR** Location: **SW**

ADA ID: **RPAT220223095352** Ramp Type: **Type 3 - Combination 1** Initial Pass/Fail: **Fail** Overall Compliance: **No** Severity Score: **0**

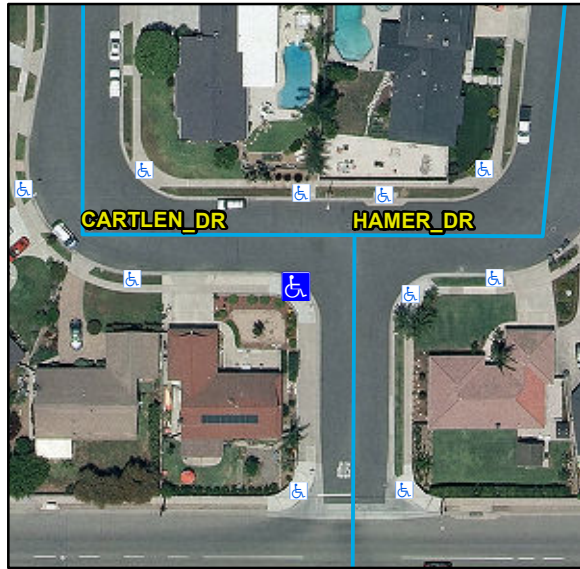
| Compliance | Description | Data | Compliance | Description | Data |
|---|---|---|---|---|---|
| <b>Yes</b> | Ramp Cross Slope LT (%) | <b>0.4</b> | <b>No</b> | Ramp Cross Slope RT (%) | <b>2.1</b> |
| <b>N/A</b> | Gutter Ponding | <b>N/A</b> | <b>No</b> | Curb Slope | <b>13.4</b> |

**Remove & Replace Curb Ramp With Two New Directional Ramps or Equivalent.**

**R304.2.2, R304.5.3, STD 1115**
