# Access Compliance Report Public Rights-of-Way (Curb Ramps)

Main Street: MEADS\_AVE Cross Street: RANDALL\_ST Location: NE

ADA ID: RPAT220223111256 Ramp Type: Type 3 - Combination 1 Initial Pass/Fail: Fail Overall Compliance: No Severity Score: 2

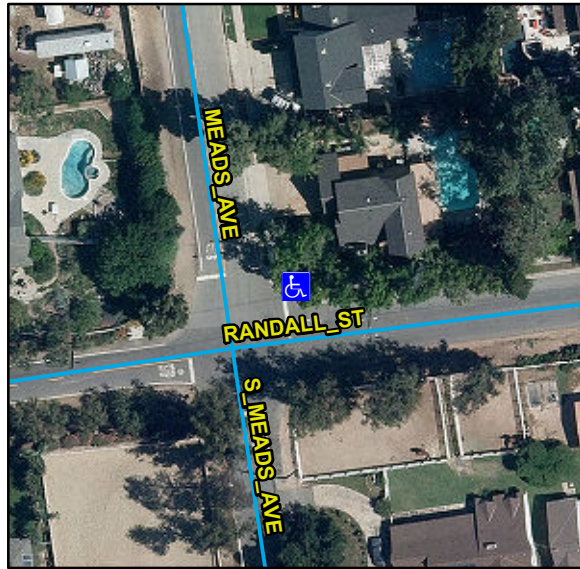
| Compliance | Description | Data | Compliance | Description | Data |
|---|---|---|---|---|---|
| No | Ramp Cross Slope LT (%) | 3.4 | No | Ramp Cross Slope RT (%) | 2.7 |
| No | Ramp Cross Slope (%) | 4.2 | N/A | Flare Traversable LT | N/A |

**Remove & Replace Curb Ramp With Two New Directional Ramps or Equivalent.**

**R304.2.2, R304.5.3, STD 1115**
