# Access Compliance Report Public Rights-of-Way (Curb Ramps)

| Main Street: RUTH_ELAINE_DR | | Cross Street: DONNIS_RD | | Location: | NW |
| ADA ID: RPAT220225110919 | Ramp Type:Type 1 - Perpendicular | Initial Pass/Fail: Fail | Overall Compliance: No | Severity Score: | 15 |

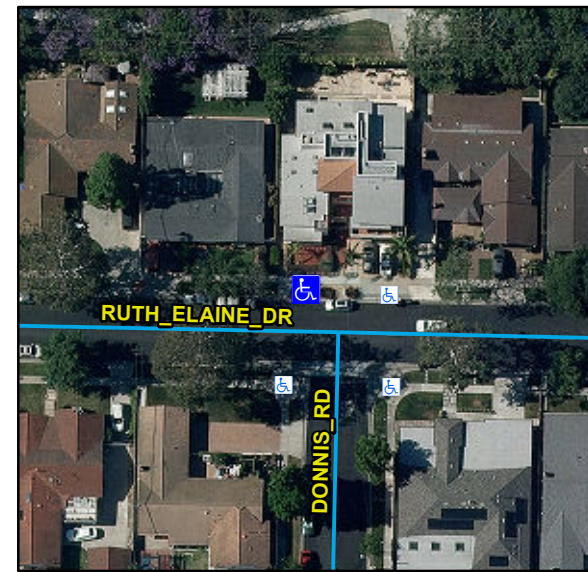
| Compliance | Description | Data | Compliance | Description | Data |
|---|---|---|---|---|---|
| No | Ramp Run Slope (%) | 9 | N/A | Flare Slope LT (%) | N/A |

Possible Solutions:

Remove & Replace Entire Ramp.

R304.2.2, STD 1115

Total Cost: \$ 3080

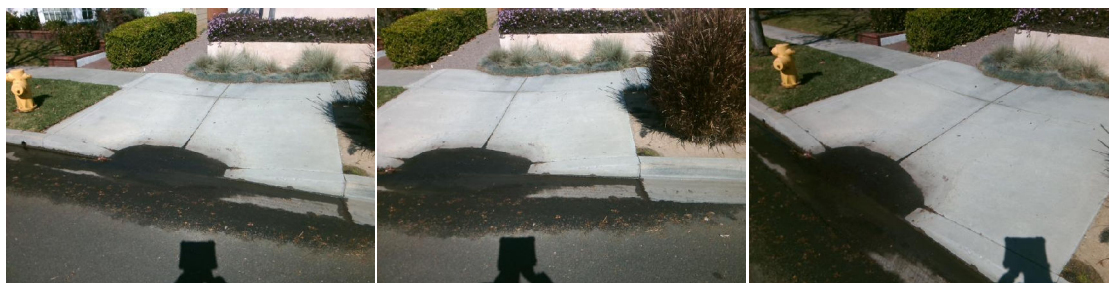
| Compliance | Description | Data | Compliance | Description | Data |
|---|---|---|---|---|---|
| N/A | Ramp Length (in) | 85 | N/A | Flare Type LT | |
| Yes | Ramp Width (in) | 54 | | | N/A |
| Yes | Ramp Cross Slope (%) | 0.3 | N/A | Flare Traversable LT | N/A |
| N/A | Gutter Ponding | Yes | N/A | Curb Slope | 0.9 |
