# Access Compliance Report Public Rights-of-Way (Curb Ramps)

| Main Street: BASKERVILLE_RD | | Cross Street: BASKERVILLE_RD | | Location: | N |
| ADA ID: RPAT220225112025 | Ramp Type: Type 4 - Parallel | Initial Pass/Fail: Fail | Overall Compliance: No | Severity Score: | 60 |

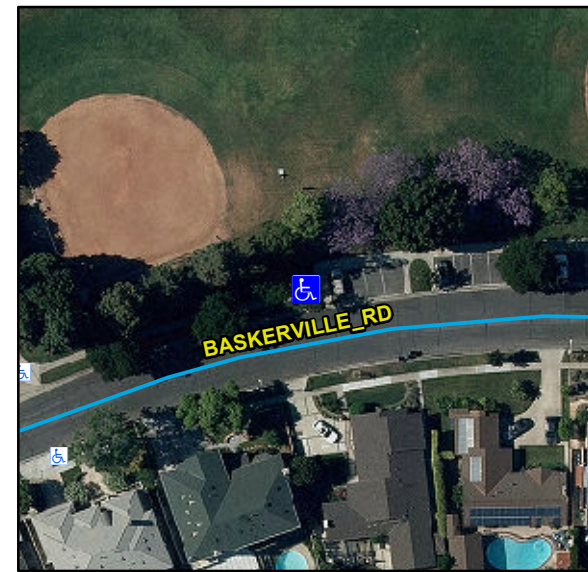
| Compliance | Description | Data | Compliance | Description | Data |
|---|---|---|---|---|---|
| No | Ramp Run Slope LT (%) | 8.6 | No | Ramp Run Slope RT (%) | 15.3 |
| No | Ramp Cross Slope LT (%) | 7.5 | No | Ramp Cross Slope RT (%) | 3.1 |

Possible Solutions:

Remove & Replace Entire Ramp.
