# Access Compliance Report Public Rights-of-Way (Curb Ramps)

| Main Street: CRAWFORD_CANYON_RD | | Cross Street: N/A | | Location: | NE |
| ADA ID: RPAT220225151044 | Ramp Type:Type 1 - Perpendicular | Initial Pass/Fail: Pass | Overall Compliance: No | Severity Score: | 5 |

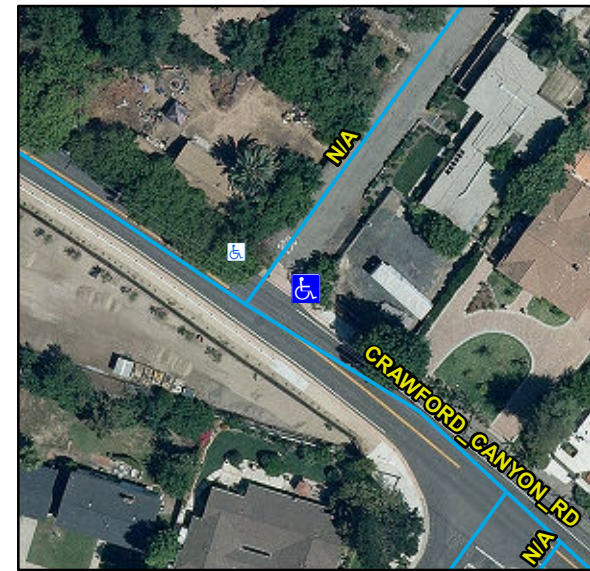
| Compliance | Description | Data | Compliance | Description | Data |
|---|---|---|---|---|---|
| Yes | Obstructions Present? | No | N/A | Utilities Present? | Yes |
| | Obstruction Dimensions | N/A | | ManHole | |

| Compliance | Description | Data | Compliance | Description | Data |
|---|---|---|---|---|---|
| N/A | Landing Shared | Yes | No | DWS Full Width | No |

**Remove & Replace Detectable Warning System.  
Utility Present.**

R305.1.4, STD 1115

Total Cost: \$ 800

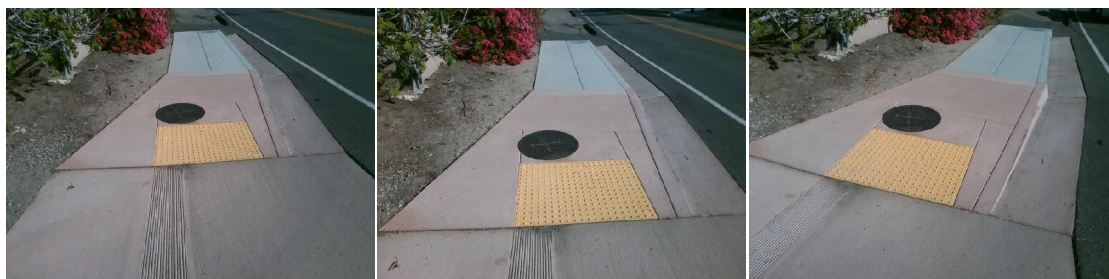
| Compliance | Description | Data | Compliance | Description | Data |
|---|---|---|---|---|---|
| Yes | Overall Surface Condition: Acceptable | | Yes | Perp Joint Present | Yes |
| | Cross Gutter Present? | Yes | | Spandrel Present? | Yes |
| | Replace Cross Gutter? | No | | Replace Spandrel? | No |
