# Access Compliance Report Public Rights-of-Way (Curb Ramps)

| Main Street: CRAWFORD_CANYON_RD | | Cross Street: N/A | | Location: | NW |
| ADA ID: RPAT220225152023 | Ramp Type:Type 1 - Perpendicular | Initial Pass/Fail: Pass | Overall Compliance: No | Severity Score: | 10 |

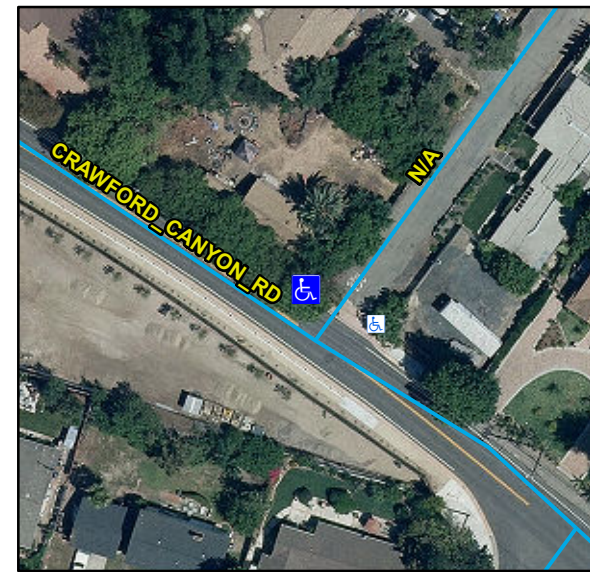
| Compliance | Description | Data | Compliance | Description | Data |
|---|---|---|---|---|---|
| N/A | Landing Shared | No | No | DWS Full Width | No |
| No | Gutter Run Slope (%) | 5.4 | | Road Cross Slope (%) | N/A |

#### Possible Solutions:

Remove & Replace Detectable Warning System.  
Remove & Replace Gutter.

R305.1.4, R304.5.4, STD 1115

Total Cost: \$ 1052
