# Access Compliance Report Public Rights-of-Way (Curb Ramps)

Main Street: ARROYO\_AVE Cross Street: ARROYO\_LINDO\_DR Location: SE

ADA ID: RPAT220225165135 Ramp Type: Type 4 - Parallel Initial Pass/Fail: Pass Overall Compliance: No Severity Score: 6

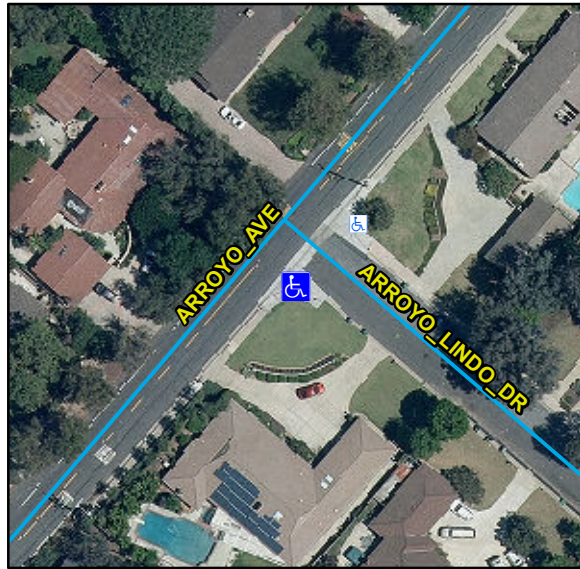
| Compliance | Description | Data | Compliance | Description | Data |
|---|---|---|---|---|---|
| No | Ramp Cross Slope LT (%) | 2.6 | Yes | Ramp Cross Slope RT (%) | 1.3 |
| No | Gutter Run Slope (%) | 6.5 | | Road Cross Slope (%) | 1.4 |

Remove & Replace Curb Ramp With Two New Directional Ramps or Equivalent. Remove & Replace Gutter.
