# Access Compliance Report Public Rights-of-Way (Curb Ramps)

Main Street: NEWPORT\_BLV Cross Street: N/A Location: SW

ADA ID: RPAT220225170708 Ramp Type: Type 1 - Perpendicular Diagonal Initial Pass/Fail: Pass Overall Compliance: No Severity Score: 10

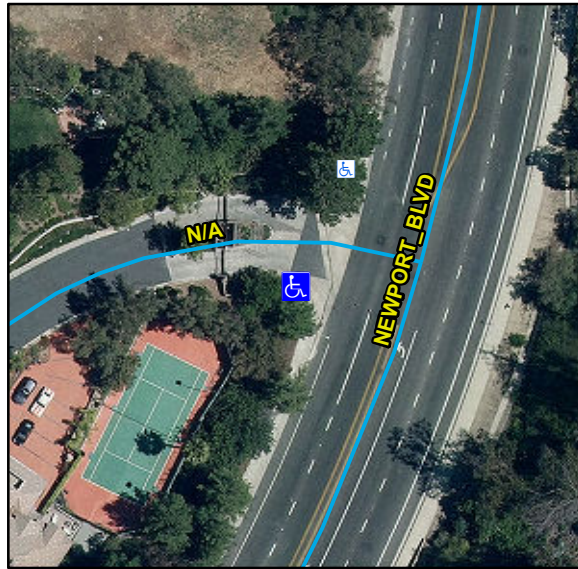
| Compliance | Description | Data | Compliance | Description | Data |
|---|---|---|---|---|---|
| Yes | Landing Width (in) | 48 | No | Flare Slope RT (%) | 13.5 |
| No | Landing Cross Slope (%) | 4.2 | Yes | DWS Provided | Yes |
| No | Gutter Run Slope (%) | 6.2 | | Road Cross Slope (%) | 4 |

Remove & Replace Curb Ramp With Two New Directional Ramps or Equivalent. Remove & Replace Gutter.

R304.5.3, R304.2.3, R304.5.4, STD 1115
