# Access Compliance Report Public Rights-of-Way (Curb Ramps)

| Main Street: NEWPORT_BLVD | | Cross Street: N/A | | Location: | NW |
| ADA ID: RPAT220225171427 | Ramp Type:Type 1 - Perpendicular | Initial Pass/Fail: Fail | Overall Compliance: No | Severity Score: | 15 |

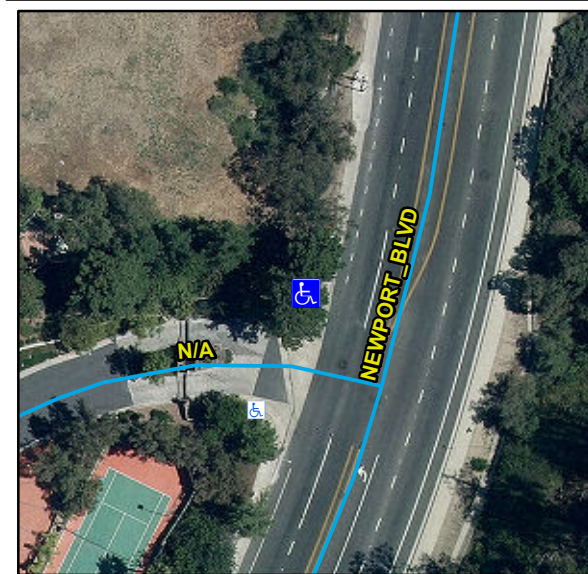
OC Std/PROW:

R304.2.2, STD 1115

| Compliance | Description | Data | Compliance | Description | Data |
|---|---|---|---|---|---|
| No | Ramp Run Slope (%) | 8.5 | N/A | Flare Slope LT (%) | N/A |

Possible Solutions:

Remove & Replace Entire Ramp.
