# Access Compliance Report Public Rights-of-Way (Curb Ramps)

Main Street: FAIRHAVEN\_AVE Cross Street: CABARET\_CT Location: SE

ADA ID: RPAT220301105301 Ramp Type: Type 1 - Perpendicular Diagonal Initial Pass/Fail: Fail Overall Compliance: No Severity Score: 2

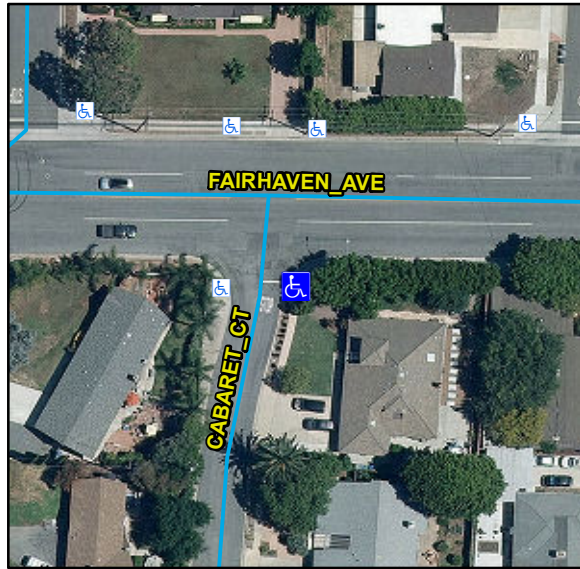
| Compliance | Description | Data | Compliance | Description | Data |
|---|---|---|---|---|---|
| No | Ramp Cross Slope (%) | 2.2 | N/A | Flare Traversable LT | N/A |

Remove & Replace Curb Ramp With Two New Directional Ramps or Equivalent.

R304.5.3, STD 1115
