# Access Compliance Report Public Rights-of-Way (Curb Ramps)

Main Street: N/A Cross Street: FOWLER\_AVE Location: NW

ADA ID: RPAT220301111032 Ramp Type: Type 1 - Perpendicular Initial Pass/Fail: Fail Overall Compliance: No Severity Score: 2

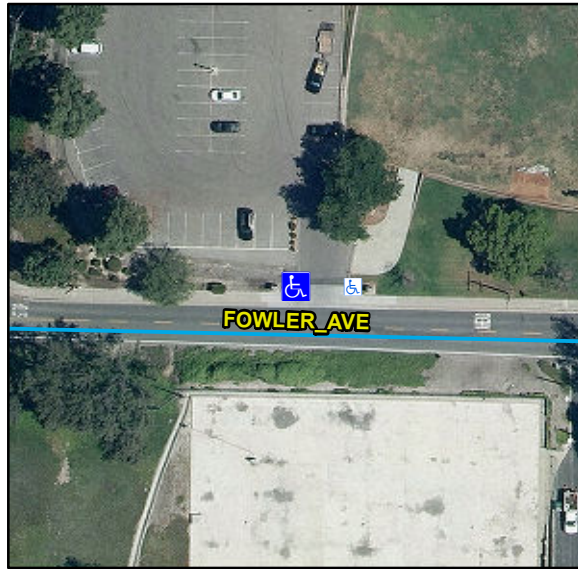
| Compliance | Description | Data | Compliance | Description | Data |
|---|---|---|---|---|---|
| No | Ramp Cross Slope (%) | 3.5 | N/A | Flare Traversable LT | N/A |

**Remove & Replace Entire Ramp.**

**R304.5.3, STD 1115**
