# Access Compliance Report Public Rights-of-Way (Curb Ramps)

Main Street: N/A Cross Street: CRAWFORD\_CANYON\_RD Location: SW

ADA ID: RPAT220301120359 Ramp Type: Type 6 - Directional 1 Initial Pass/Fail: Fail Overall Compliance: No Severity Score: 0

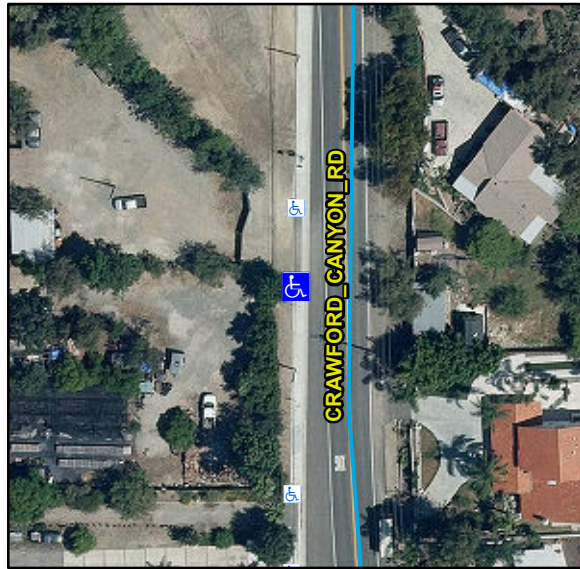
| Compliance | Description | Data | Compliance | Description | Data |
|---|---|---|---|---|---|
| N/A | Ramp Length (in) | 78 | N/A | Flare Type LT | |
| Yes | Ramp Width (in) | 60 | | | Sloped |
| Yes | Ramp Run Slope (%) | 3.3 | N/A | Flare Slope LT (%) | 3.3 |
| Yes | Ramp Cross Slope (%) | 1.5 | N/A | Flare Traversable LT | Yes |
| N/A | Gutter Ponding | No | Yes | Curb Slope | 0.8 |
| Yes | Gutter Lip Height (in) | 0 | | Road Run Slope (%) | N/A |
| Yes | Overall Surface Condition | Acceptable | Yes | Perp Joint Present | Yes |

Remove & Replace Entire Ramp.

STD 1115

Total Cost: \$ 3080
