# Access Compliance Report Public Rights-of-Way (Curb Ramps)

Main Street: N/A Cross Street: CRAWFORD\_CANYON\_RD Location: NW

ADA ID: RPAT220301121033 Ramp Type: Type 6 - Directional 1 Initial Pass/Fail: Fail Overall Compliance: No Severity Score: 2

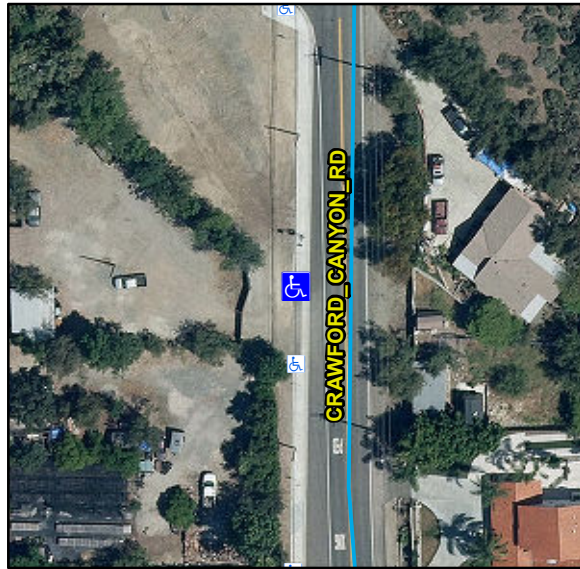
| Compliance | Description | Data | Compliance | Description | Data |
|---|---|---|---|---|---|
| No | Ramp Cross Slope (%) | 2.1 | N/A | Flare Traversable LT | N/A |

Remove & Replace Entire Ramp.

R304.5.3, STD 1115
