# Access Compliance Report Public Rights-of-Way (Curb Ramps)

Main Street: N/A Cross Street: NEWPORT\_BLV Location: NE

ADA ID: RPAT220301123505 Ramp Type:Type 1 - Perpendicular Diagonal Initial Pass/Fail: Fail Overall Compliance: No Severity Score: 15

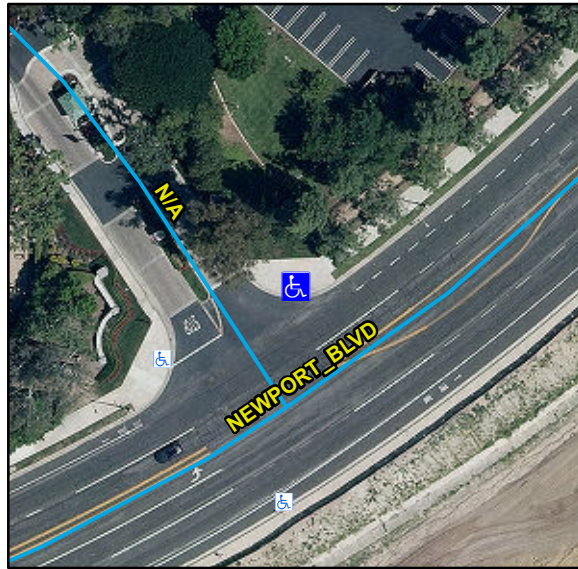
| Compliance | Description | Data | Compliance | Description | Data |
|---|---|---|---|---|---|
| No | Ramp Cross Slope (%) | 6.3 | N/A | Flare Traversable LT | N/A |

Remove & Replace Curb Ramp With Two New Directional Ramps or Equivalent.

R304.5.3, STD 1115
