# Access Compliance Report Public Rights-of-Way (Curb Ramps)

Main Street: NEWPORT\_BLV Cross Street: N/A Location: NW

ADA ID: RPAT220301124220 Ramp Type: Type 1 - Perpendicular Diagonal Initial Pass/Fail: Fail Overall Compliance: No Severity Score: 16

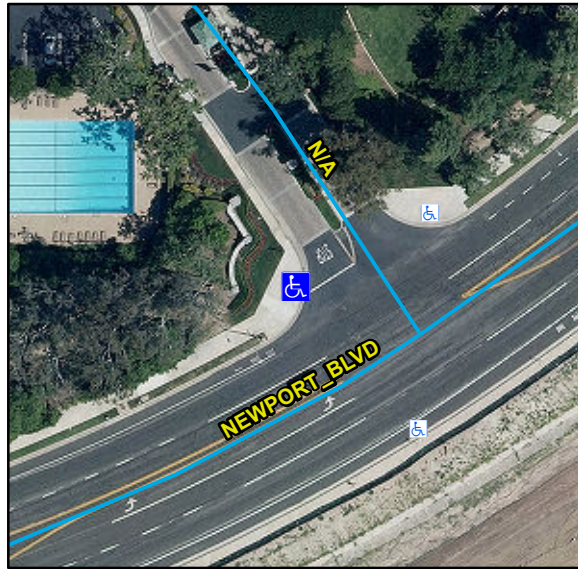
| Compliance | Description | Data | Compliance | Description | Data |
|---|---|---|---|---|---|
| No | Ramp Run Slope (%) | 9.8 | N/A | Flare Slope LT (%) | N/A |
| No | Ramp Cross Slope (%) | 3.7 | N/A | Flare Traversable LT | N/A |

Remove & Replace Curb Ramp With Two New Directional Ramps or Equivalent.

R304.2.2, R304.5.3, STD 1115
