# Access Compliance Report Public Rights-of-Way (Curb Ramps)

Main Street: ENDRY\_ST Cross Street: BANTA\_AVE Location: NE

ADA ID: RPRK210916115035 Ramp Type: Type 1 - Perpendicular Diagonal Initial Pass/Fail: Fail Overall Compliance: No Severity Score: 35

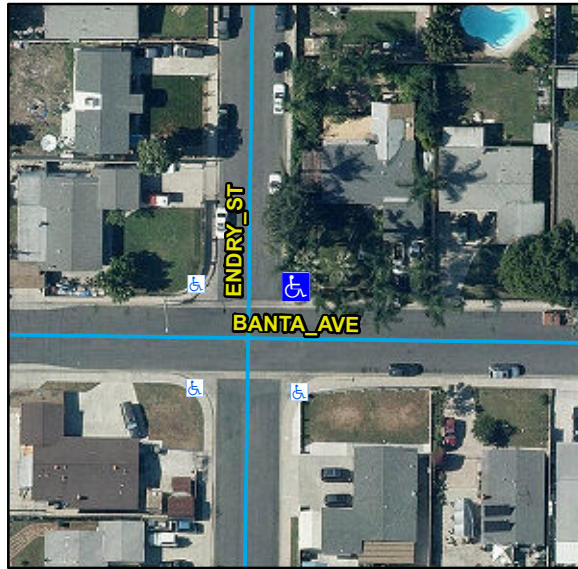
| Compliance | Description | Data | Compliance | Description | Data |
|---|---|---|---|---|---|
| No | Ramp Width (in) | 39 | | | N/A |
| No | Ramp Run Slope (%) | 13.5 | N/A | Flare Slope LT (%) | N/A |

Remove & Replace Curb Ramp With Two New Directional Ramps or Equivalent.

R304.5.1, R304.2.2, STD 1115
