Access Compliance Report Public Rights-of-Way (Curb Ramps)

Main Street: GILBERT_ST **Cross Street:** KATELLA_AVE **Location:** SW

ADA ID: RPRK210916134658 **Ramp Type:** Type 1 - Perpendicular Diagonal Initial Pass/Fail: Fail **Overall Compliance:** No **Severity Score:** 15

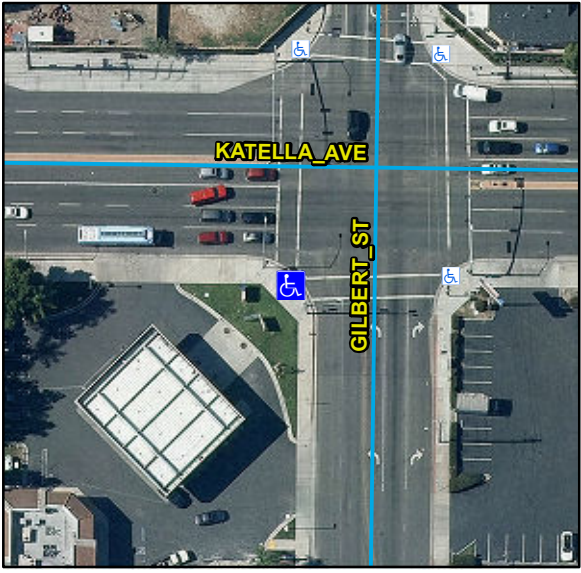
Compliance	Description	Data	Compliance	Description	Data
N/A	Ramp Length (in)	120	N/A	Flare Type LT	
Yes	Ramp Width (in)	48			N/A
No	Ramp Run Slope (%)	9.4	N/A	Flare Slope LT (%)	N/A
Yes	Ramp Cross Slope (%)	0.3	N/A	Flare Traversable LT	N/A
N/A	Landing Present	N/A	N/A	Flare Type RT	
N/A	Landing Length (in)	N/A			N/A
N/A	Landing Width (in)	N/A	N/A	Flare Slope RT (%)	N/A
N/A	Landing Run Slope (%)	N/A	N/A	Flare Traversable RT	N/A
N/A	Landing Cross Slope (%)	N/A	N/A	DWS Provided	N/A
N/A	Landing Movement Obstructed?	N/A	N/A	DWS Contrast	N/A
	Landing Movement Type	N/A	N/A	DWS Length (in)	N/A
N/A	Landing Shared	N/A	N/A	DWS Full Width	N/A
N/A	Clear Space	Yes	N/A	DWS Offset Left (in)	N/A
N/A	Clear Space To Crosswalk (in)	48	N/A	DWS Offset Right (in)	N/A
N/A	Marked Crosswalk 1	Yes	N/A	Marked Crosswalk 2	Yes
	Crossing 1 Direction	E		Crossing 2 Direction	N
	Marked Crosswalk 1 Width (in)	120		Marked Crosswalk 2 Width (in)	118

N/A	Ramp Inside Crosswalk 1	Yes	Yes	Ramp Inside Crosswalk 2	Yes
	Crossing 1 Slope (%)	6.5		Crossing 2 Slope (%)	6
	Crossing 1 Cross Slope (%)	2.1		Crossing 2 Cross Slope (%)	3.5
N/A	Gutter Ponding	N/A	No	Curb Slope	8.5
Yes	Gutter Lip Height (in)	0		Road Run Slope (%)	9.3
N/A	Gutter Run Slope (%)	N/A		Road Cross Slope (%)	0.5
N/A	Gutter Cross Slope (%)	N/A			
Yes	Overall Surface Condition: Acceptable		Yes	Perp Joint Present	Yes
	Cross Gutter Present?	No		Spandrel Present?	No
	Replace Cross Gutter?	N/A		Replace Spandrel?	N/A

Possible Solutions:
Remove & Replace Curb Ramp With Two New Directional Ramps or Equivalent.

OC Std/PROW:
 R304.2.2, STD 1115
